**UNITED STATES ENVIRONMENTAL PROTECTION AGENCY**  
**RCRA Compliance Evaluation Inspection**

Ashland Performance Materials  
Maleic Anhydride Neal Plant  
100 Big Sandy River Road  
Kenova, West Virginia 25530

Date of Inspection: 1/26/12

RCRA Identification Number: WVD080645831

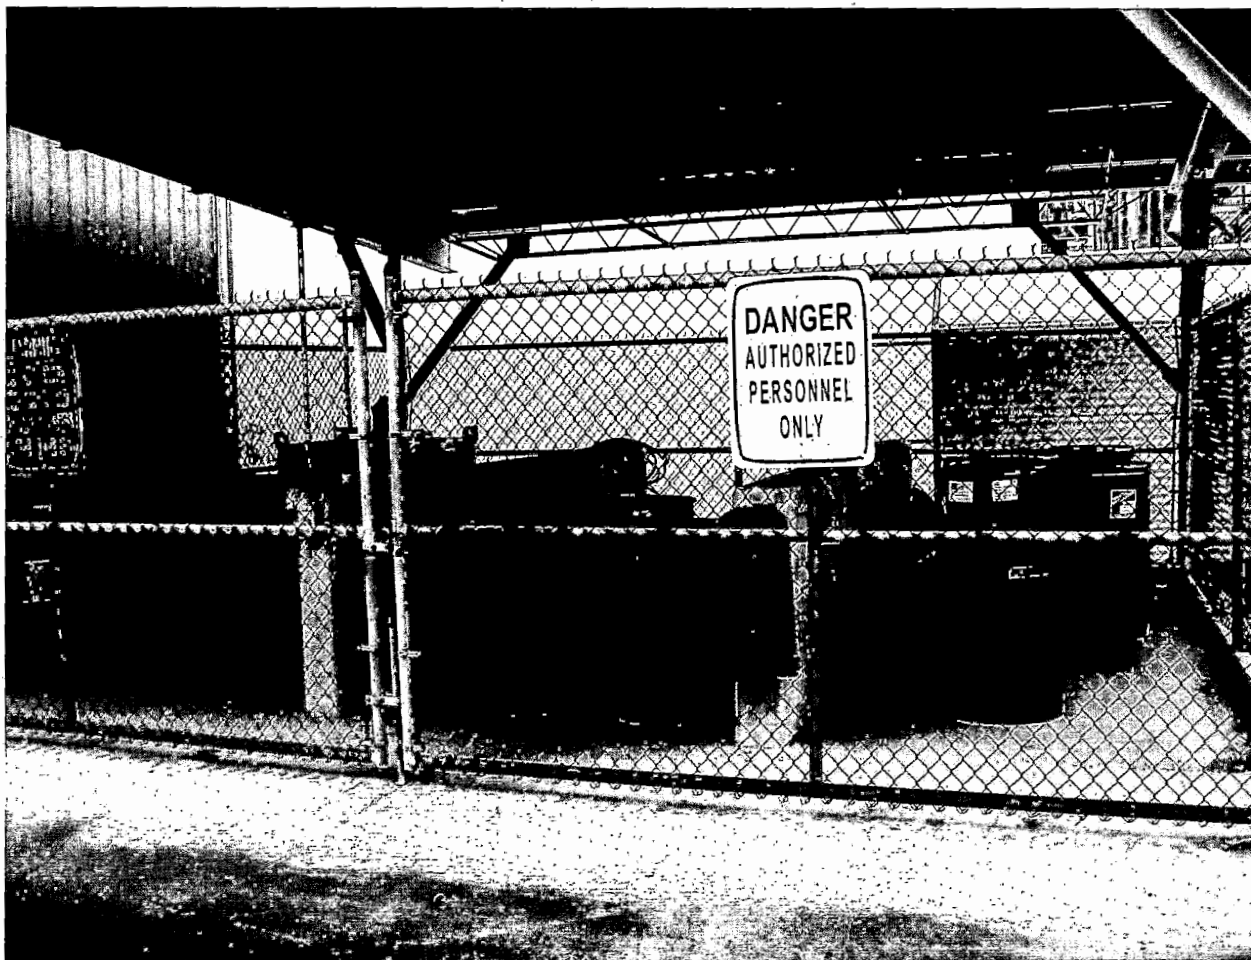
**Ashland Performance Materials**  
**Kenova, West Virginia**  
**WVD080645831**  
**Inspected: January 26, 2012**  
**Inspector: Clark S. Conover**  
**EPA/RIII/Wheeling**  
**Photo#: 1**

The physical inspection began with an inspection of the Neal Plant's less than 90 day storage area (Photo #1). The storage area is located behind a locked gated fence on an impermeable floor which is slanted to prevent any spillage from escaping. Each bay of the storage area is also equipped with a small self contained pit to contain any spillage (Photo #6). There were two 55 gallon drums of hazardous waste in the storage area at the time of the inspection. Both drums were closed, labeled, dated within the previous 90 days and although they were rusty the drums were structurally sound (Photos #2, #3 & #4). The storage area also held a 350 gallon tank utilized for the storage of used oil. The tank was closed and labeled as containing "USED OIL" (Photo #5). The next area inspected was the facility's laboratory (Photo #9). There were no hazardous wastes in the laboratory at the time of the inspection. The satellite accumulation drum utilized for laboratory waste is located on the exterior of the building in a lockable tote. The drum was labeled, closed and although the drum appeared rusty the drum was structurally sound (Photo #7). The exterior of the tote was labeled as containing Maleic Anhydride Lab Wastes and is identified as satellite accumulation area UN2215 (Photo #8).

**This photo depicts the less than 90 day storage area.**

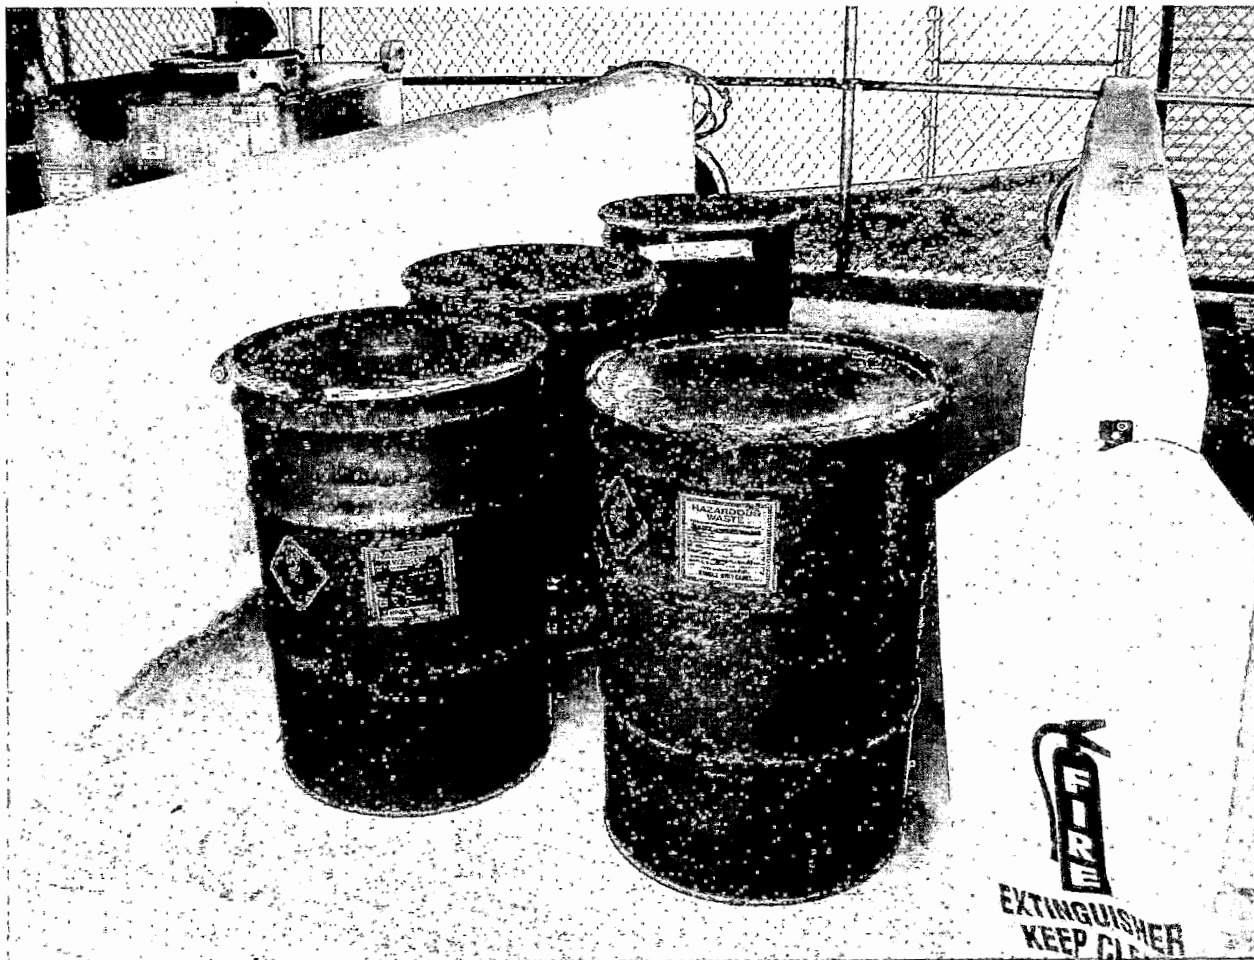
**Ashland Performance Materials**  
**Kenova, West Virginia**  
**WVD080645831**  
**Inspected: January 26, 2012**  
**Inspector: Clark S. Conover**  
**EPA/RHII/Wheeling**  
**Photo#: 4**

**This photo depicts the less than 90 day storage area.**

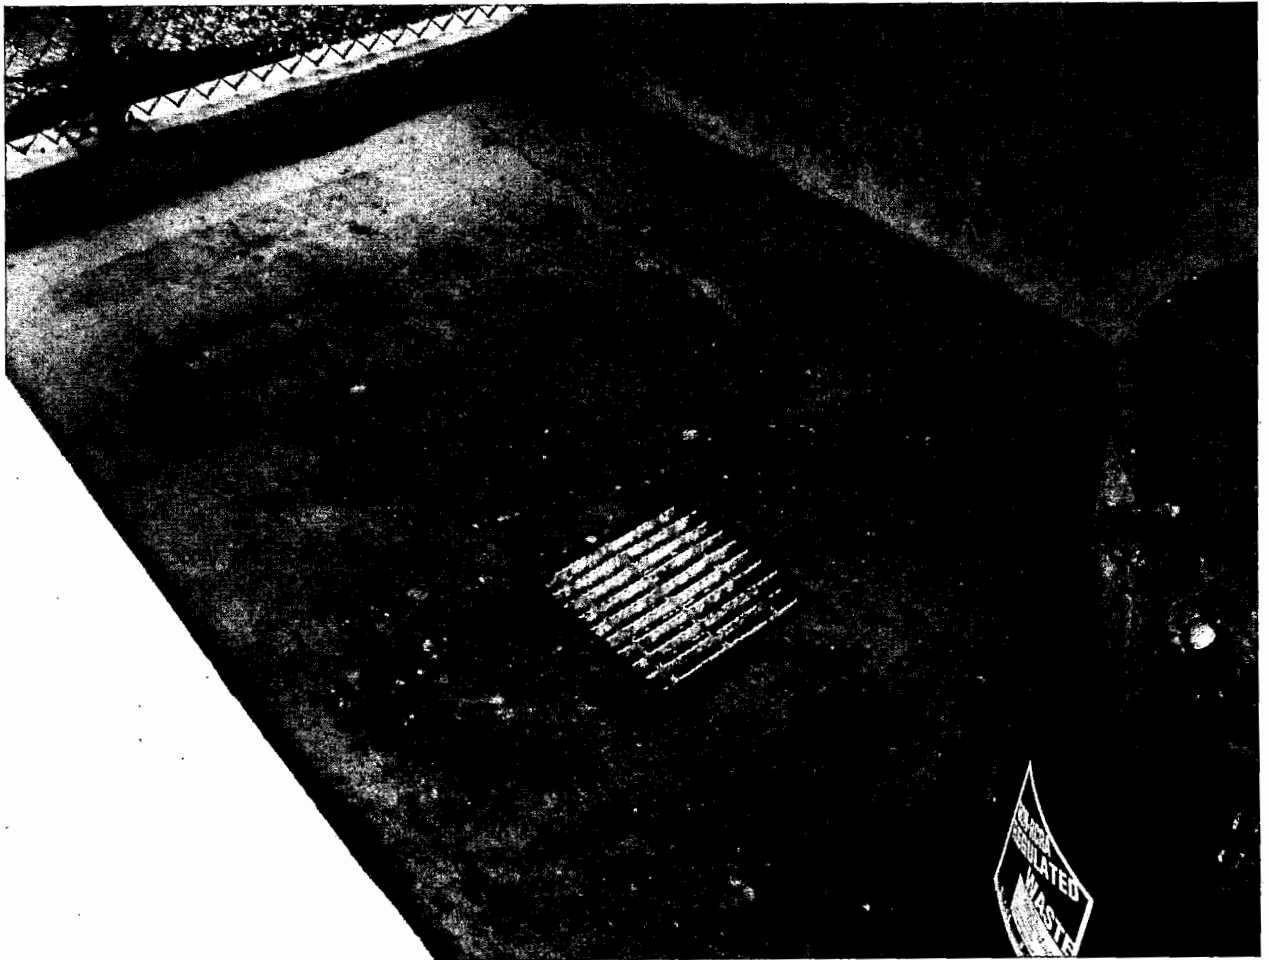
**Ashland Performance Materials**  
**Kenova, West Virginia**  
**WVD080645831**  
**Inspected: January 26, 2012**  
**Inspector: Clark S. Conover**  
**EPA/RIII/Wheeling**  
**Photo#: 6**

**This photo depicts one of the self contained sump drains in the less than 90 day storage area.**

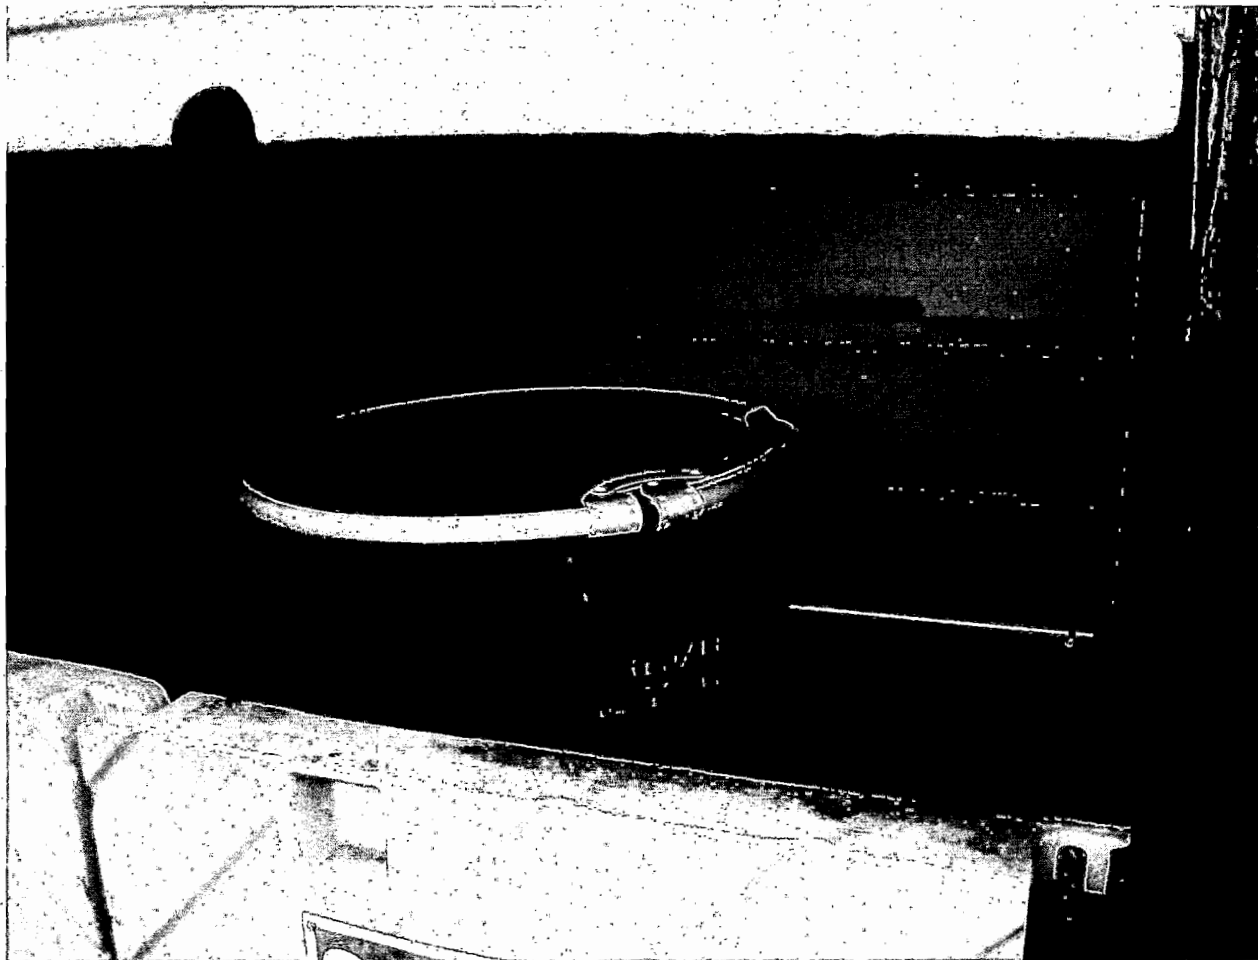
**Ashland Performance Materials**  
**Kenova, West Virginia**  
**WVD080645831**  
**Inspected: January 26, 2012**  
**Inspector: Clark S. Conover**  
**EPA/RIII/Wheeling**  
**Photo#: 7**

If no, describe. **Satellite accumulation occurs in a 55 gallon drum located within a lockable container which is located on the exterior of the laboratory. See Photos #7 & #8.**

5. Are the container(s) in good condition? **Rusty, structurally sound. Facility advised to inspect empty drums when they arrive and to reject drums which show signs of corrosion.**

**This photo depicts the satellite accumulation drum located outside of the laboratory.**

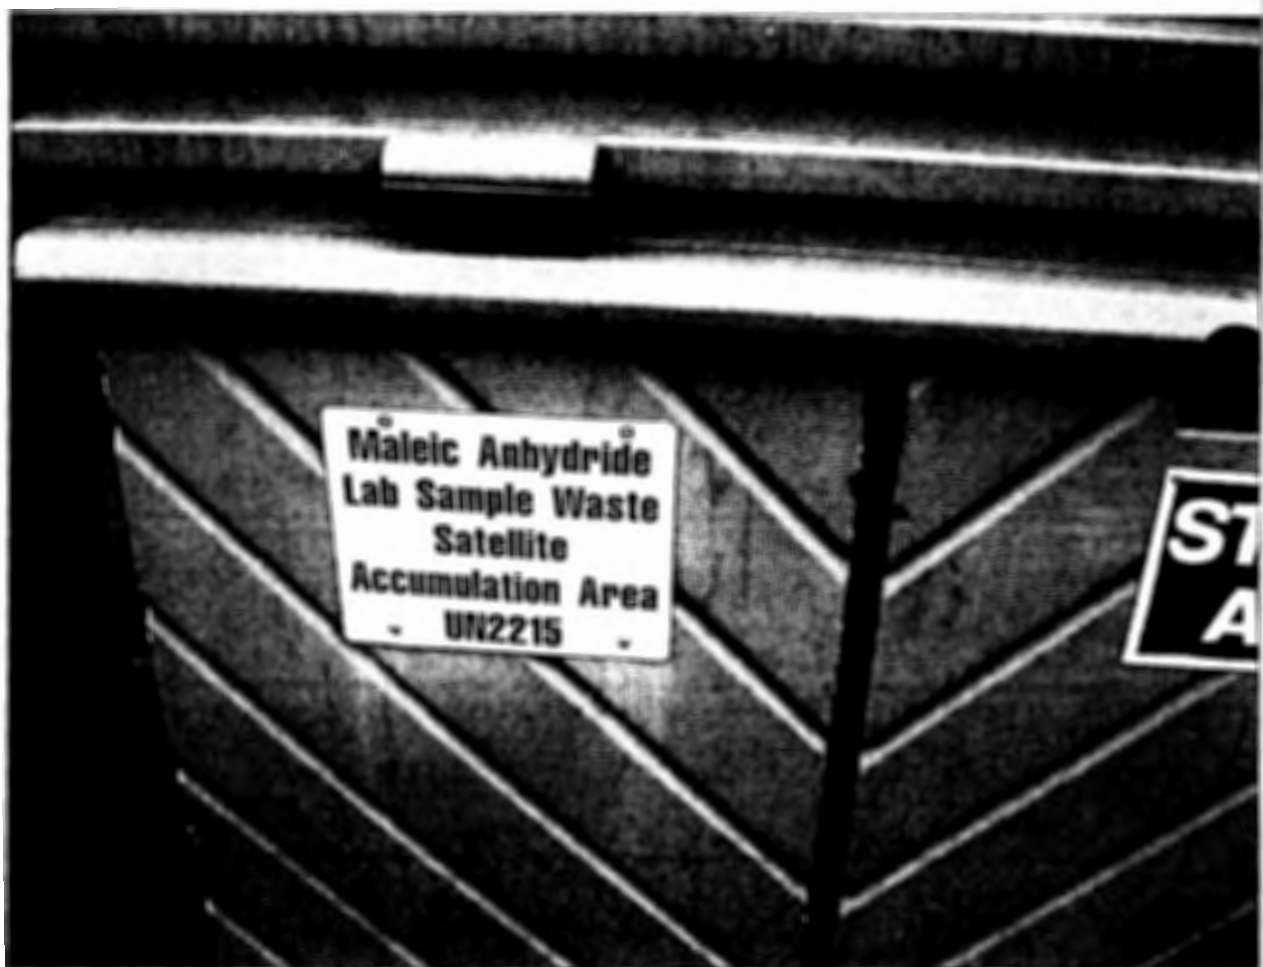
**Ashland Performance Materials**  
**Kenova, West Virginia**  
**WVD080645831**  
**Inspected: January 26, 2012**  
**Inspector: Clark S. Conover**  
**EPA/RIII/Wheeling**  
**Photo#: 8**

**This photo depicts the cabinet hold the satellite accumulation drum outside the laboratory.**

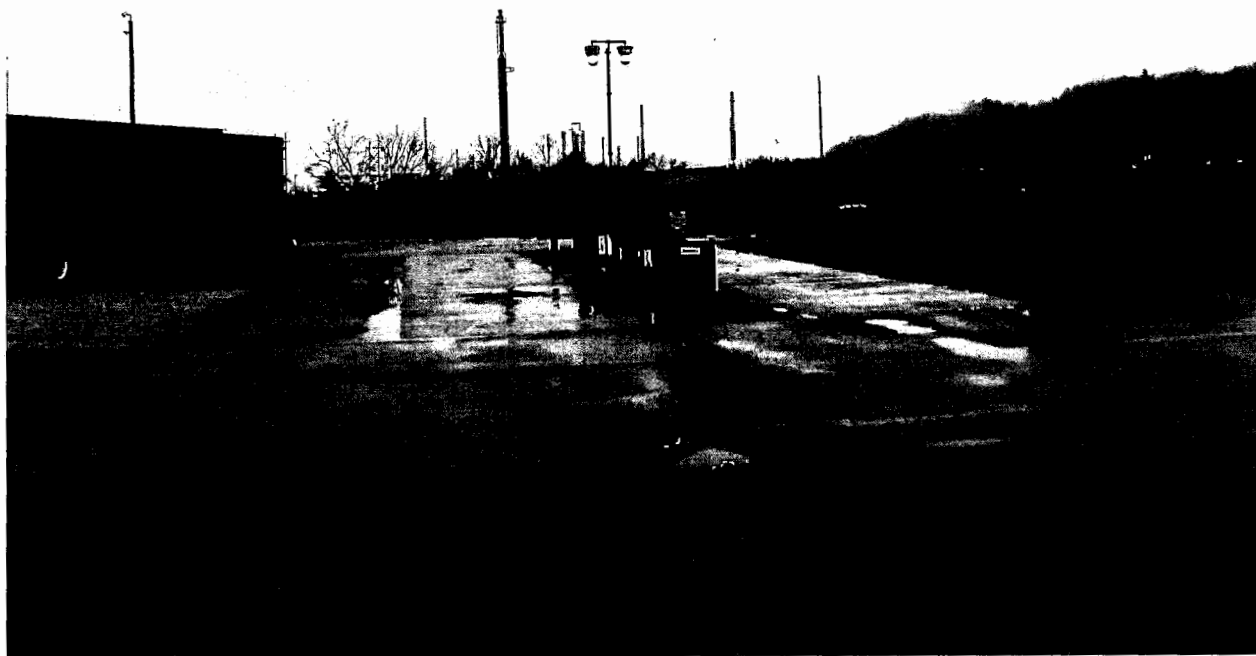
**Ashland Performance Materials**  
**Kenova, West Virginia**  
**WVD080645831**  
**Inspected: January 26, 2012**  
**Inspector: Clark S. Conover**  
**EPA/RIII/Wheeling**  
**Photo#: 10**

**This photo depicts the butane unloading area.**

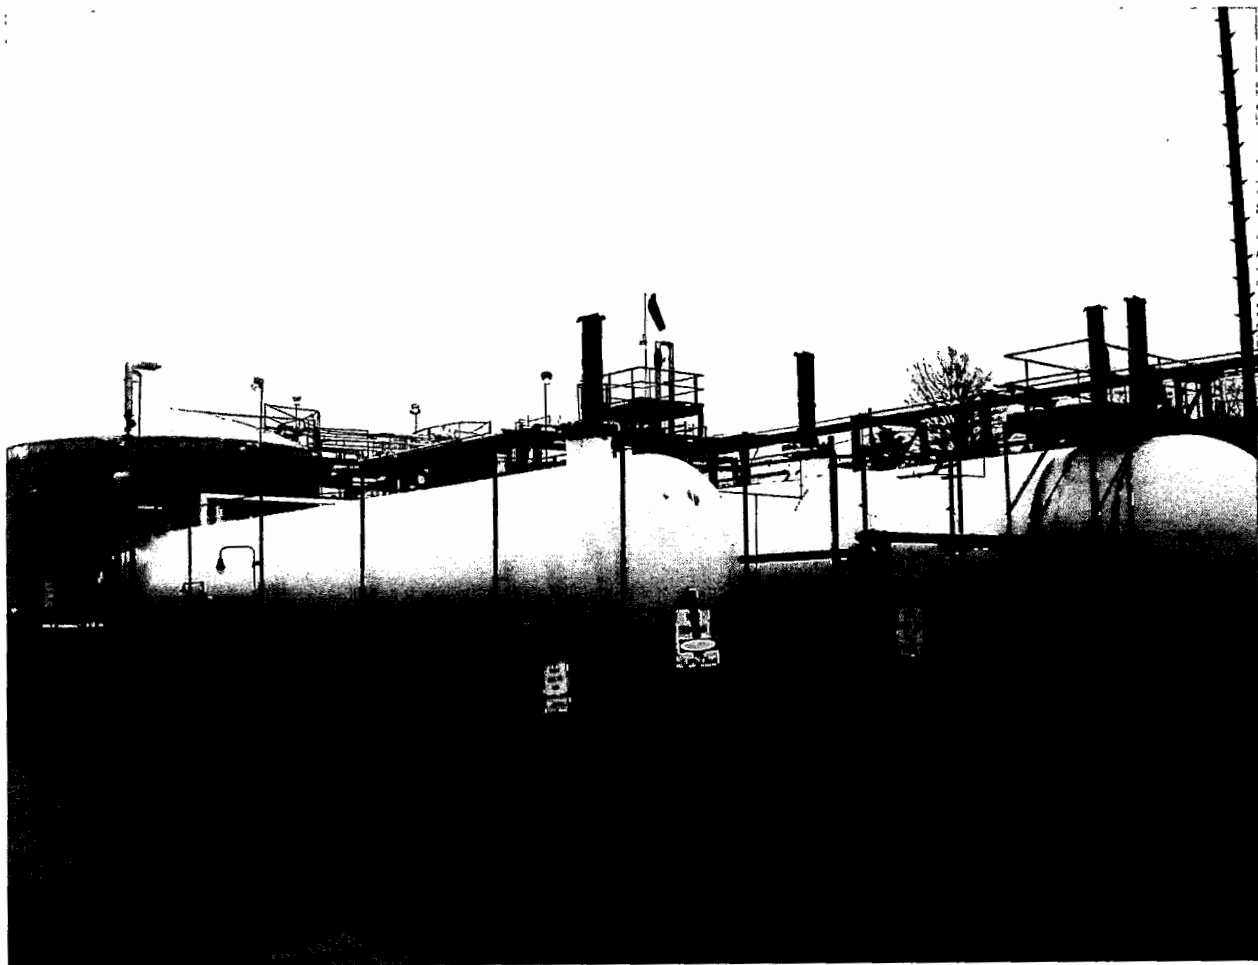
**Ashland Performance Materials**  
**Kenova, West Virginia**  
**WVD080645831**  
**Inspected: January 26, 2012**  
**Inspector: Clark S. Conover**  
**EPA/RIII/Wheeling**  
**Photo#: 11**

**This photo depicts the butane storage tanks.**

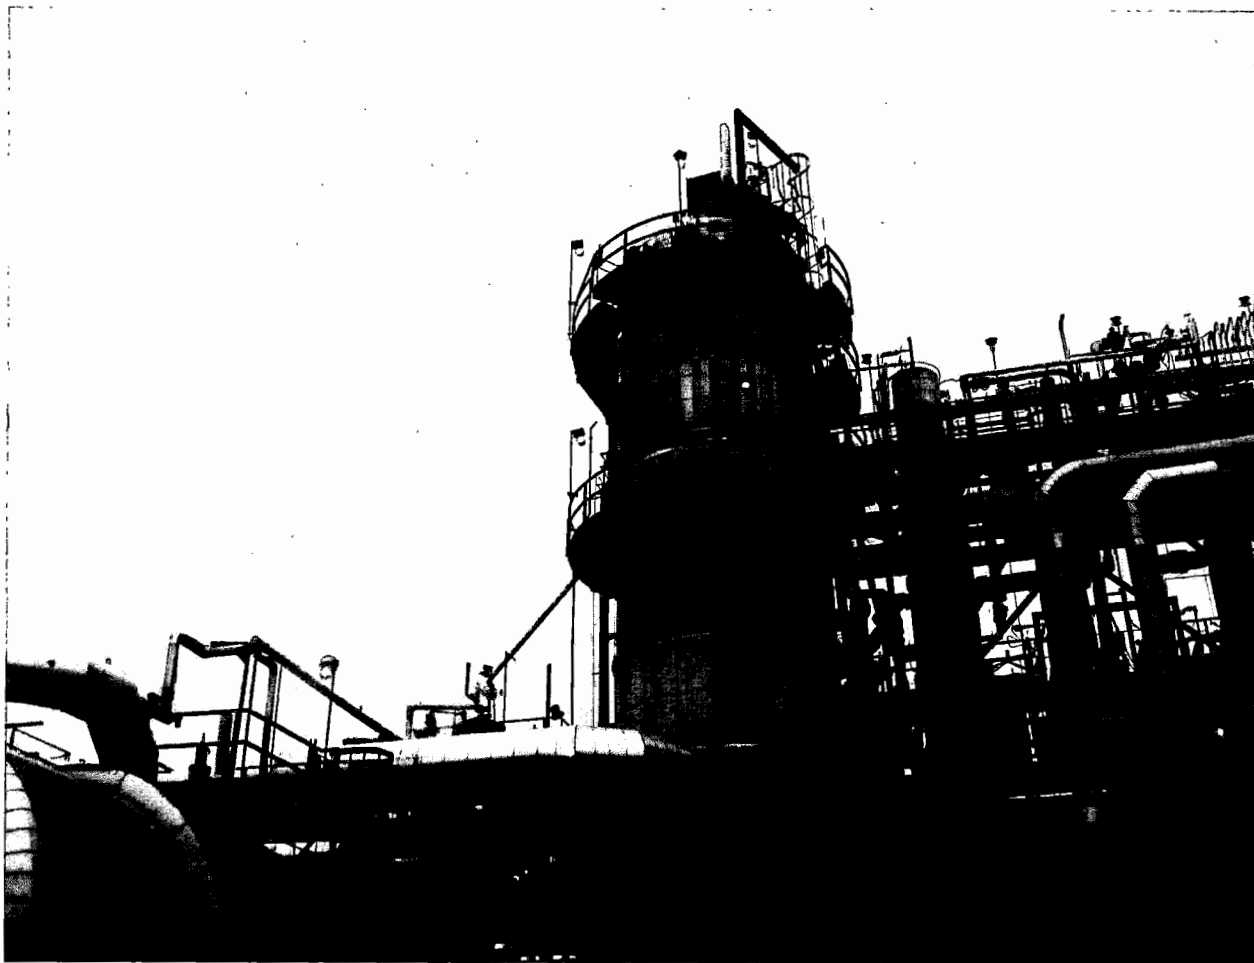
**Ashland Performance Materials**  
**Kenova, West Virginia**  
**WVD080645831**  
**Inspected: January 26, 2012**  
**Inspector: Clark S. Conover**  
**EPA/RIII/Wheeling**  
**Photo#: 21**

**This photo depicts the Batch Refiner.**

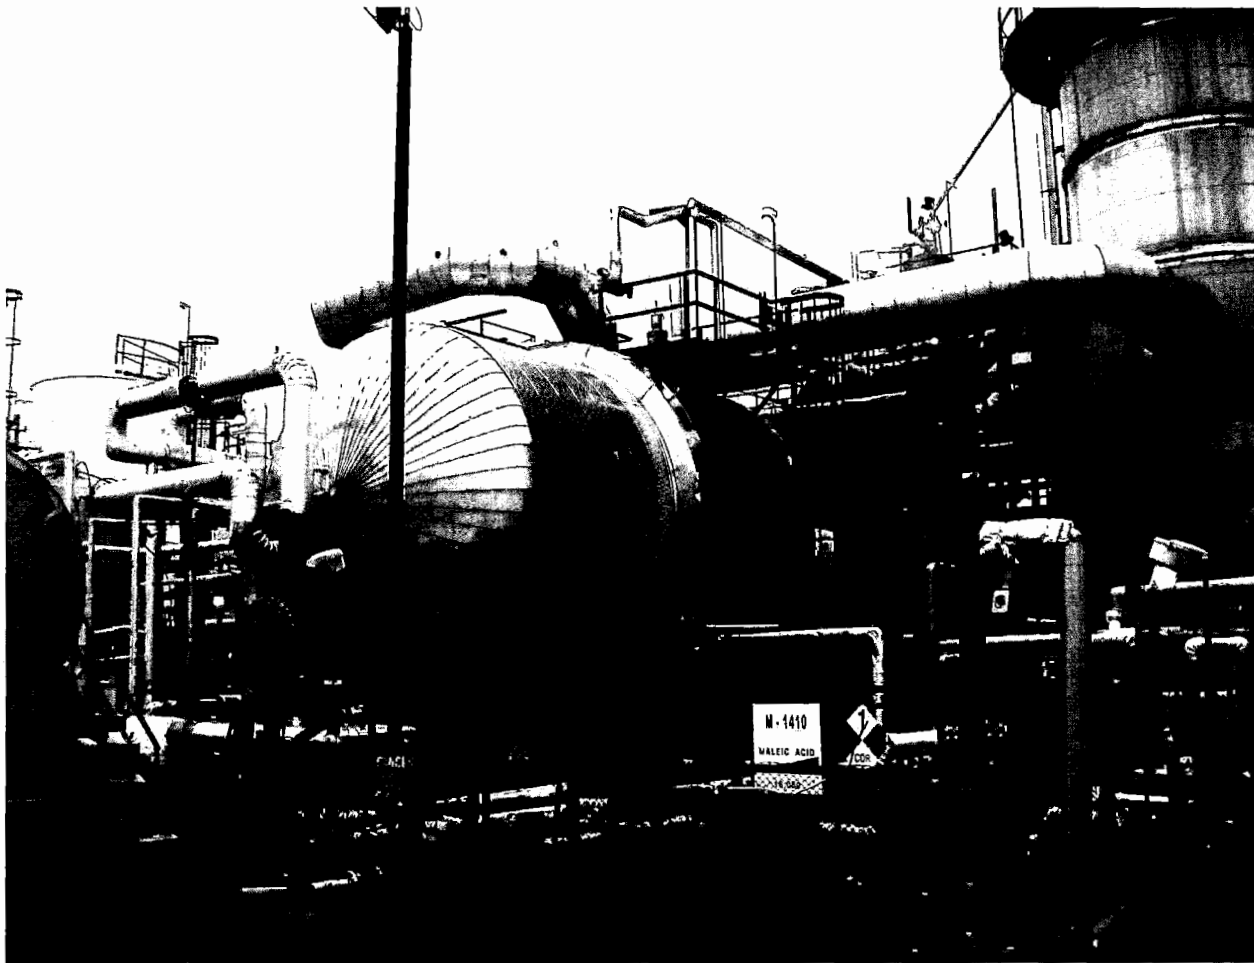
**Ashland Performance Materials  
Kenova, West Virginia  
WVD080645831  
Inspected: January 26, 2012  
Inspector: Clark S. Conover  
EPA/RIII/Wheeling  
Photo#: 22**

**This photo depicts the Still Pot.**

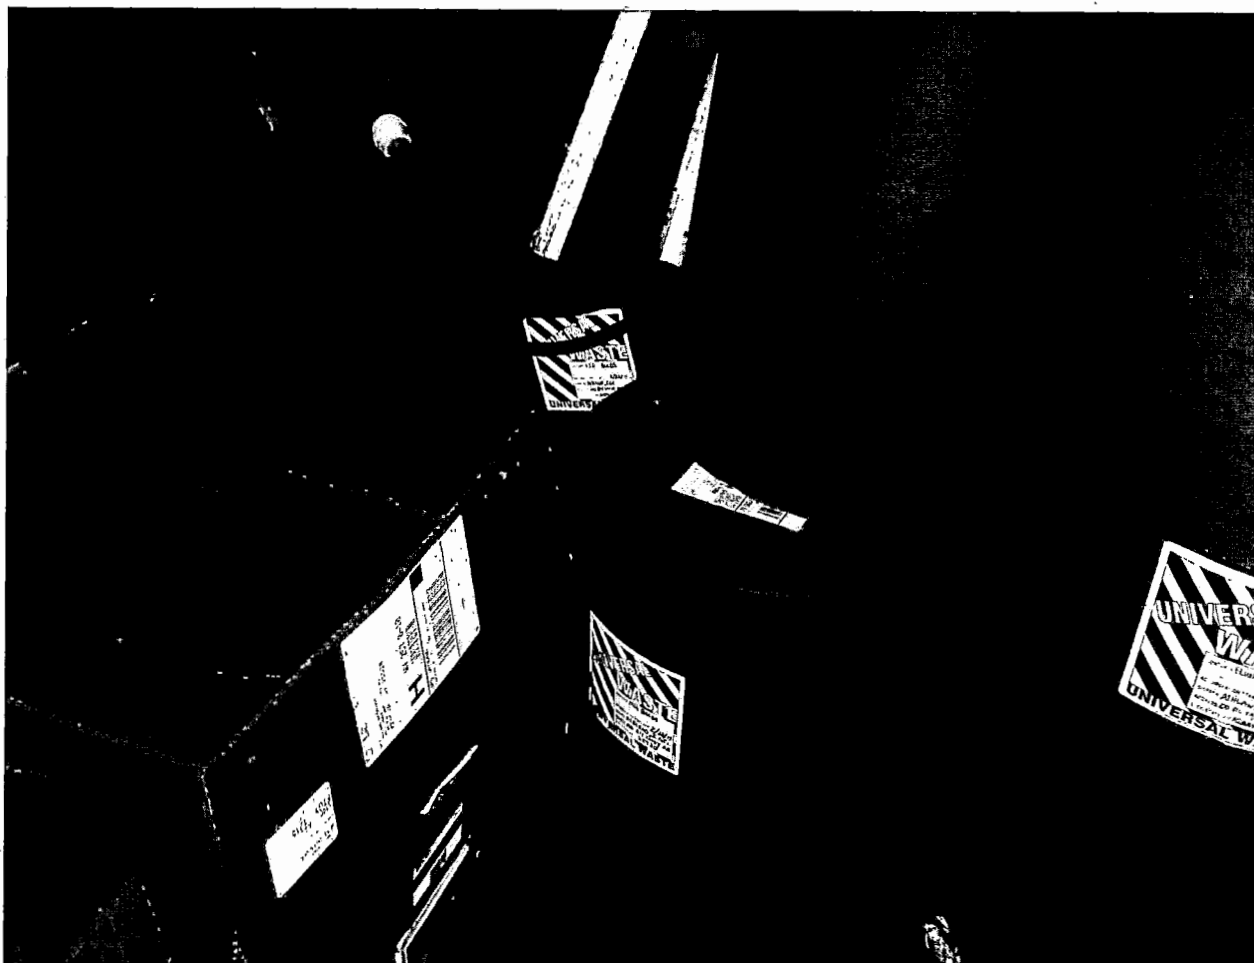
**Ashland Performance Materials**  
**Kenova, West Virginia**  
**WVD080645831**  
**Inspected: January 26, 2012**  
**Inspector: Clark S. Conover**  
**EPA/RIII/Wheeling**  
**Photo#: 25**

**This photo depicts the used fluorescent light bulb storage.**
